West Virginia Chemical Leak
Etowah, Kanawha County, West Virginia
TDD No TL01-14-01-001

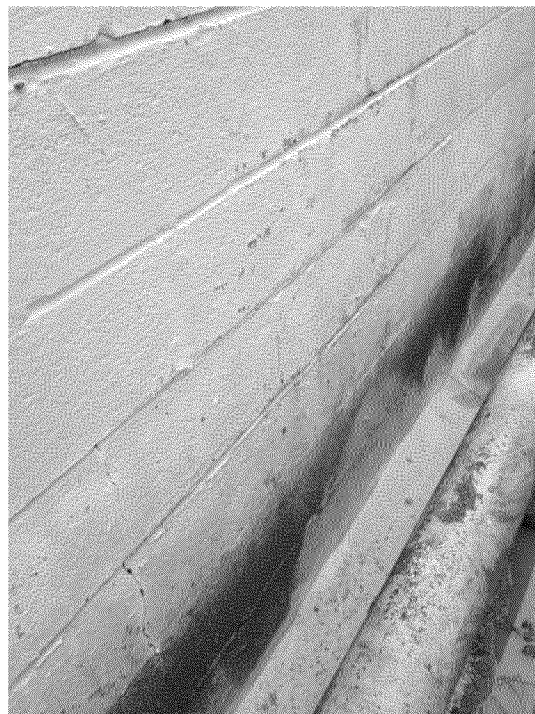
Photo No. IMG_1118; Taken on 01/11/14 at 14:51 hours by START GN. Bentonite placed along cinderblock containment wall in tank farm where MCHM was reported to have released.

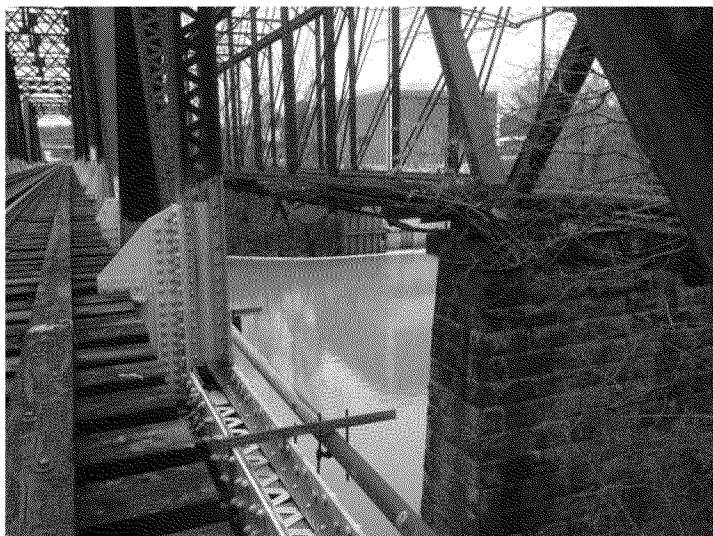
Photo No. IMG_1119; Taken on 01/11/14 at 14:51 hours by START GN. WV American water intake with sorbent boom deployed by Clean Harbors.

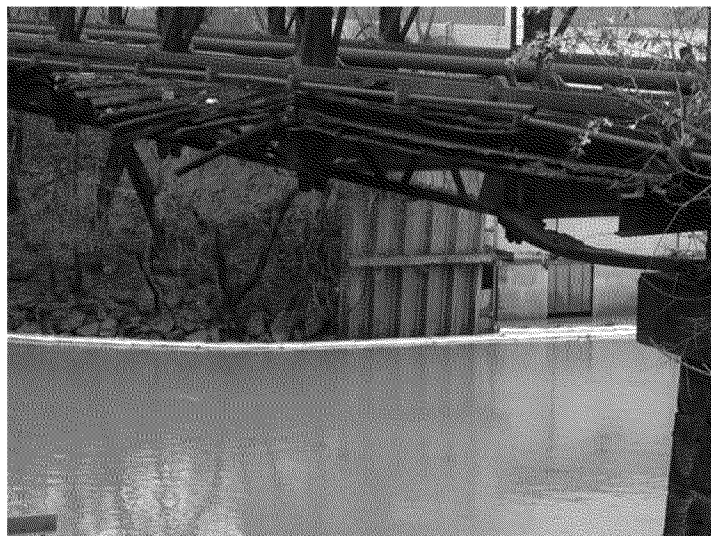
Photo No. IMG_1120; Taken on 01/11/14 at 14:54 hours by START GN. WV American water intake with sorbent boom deployed by Clean Harbors.

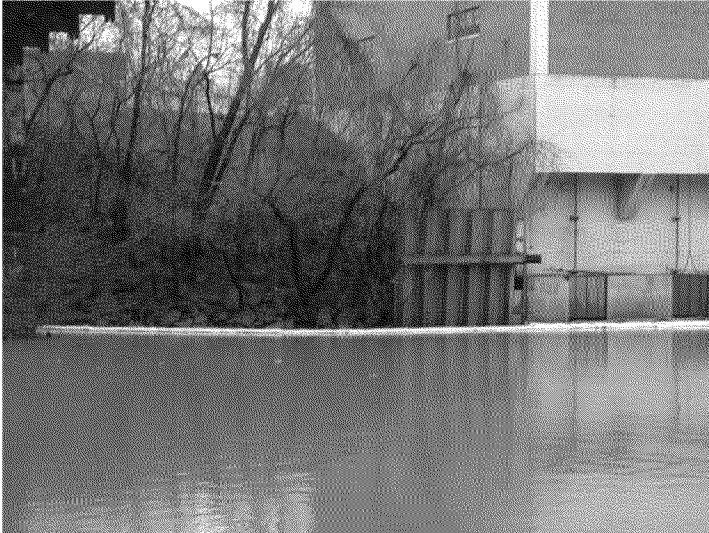
Photo No. IMG_1121; Taken on 01/11/14 at 14:54 hours by START GN. WV American water intake with sorbent boom deployed by Clean Harbors.

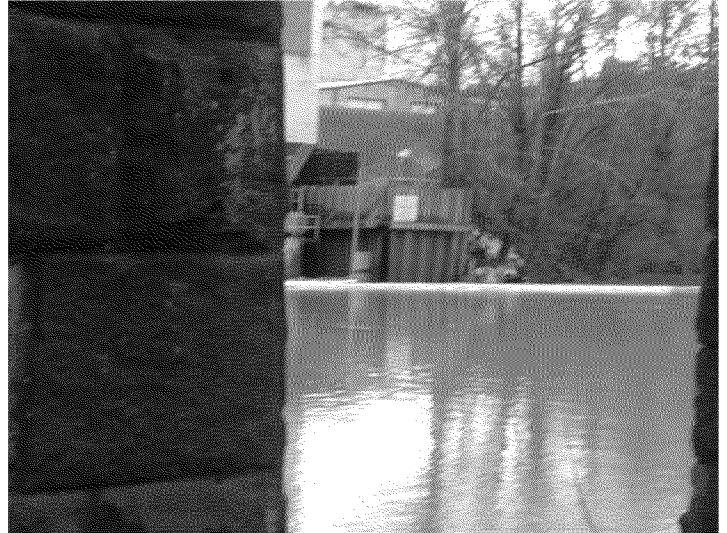
Photo No. IMG_1122; Taken on 01/11/14 at 14:55 hours by START GN. WV American water intake with sorbent boom deployed by Clean Harbors.

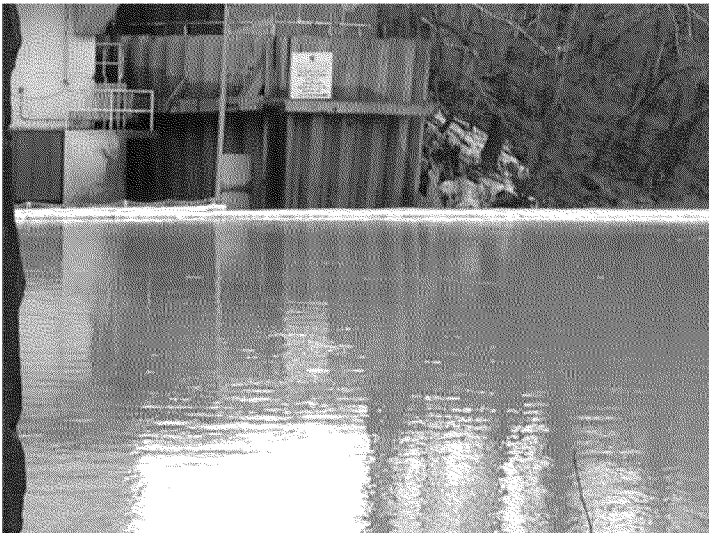
Photo No. IMG_1123; Taken on 01/11/14 at 14:56 hours by START GN. WV American water intake with sorbent boom deployed by Clean Harbors.

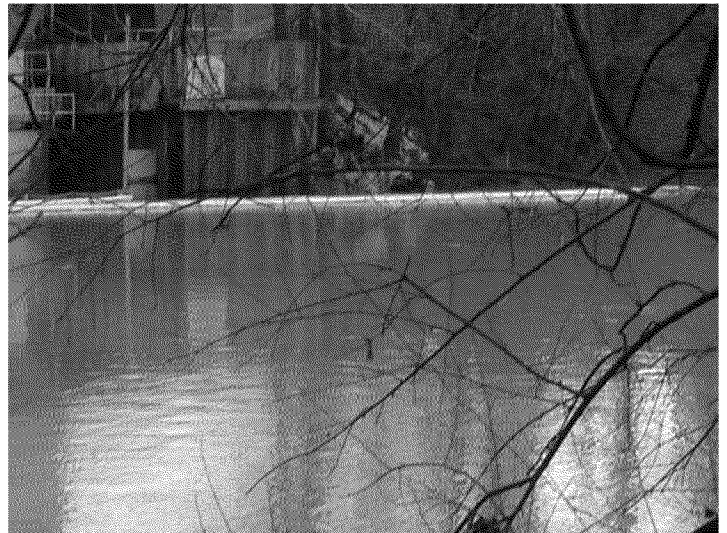
Photo No. IMG_1124; Taken on 01/11/14 at 15:53 hours by START GN. WV American water intake with sorbent boom deployed by Clean Harbors.

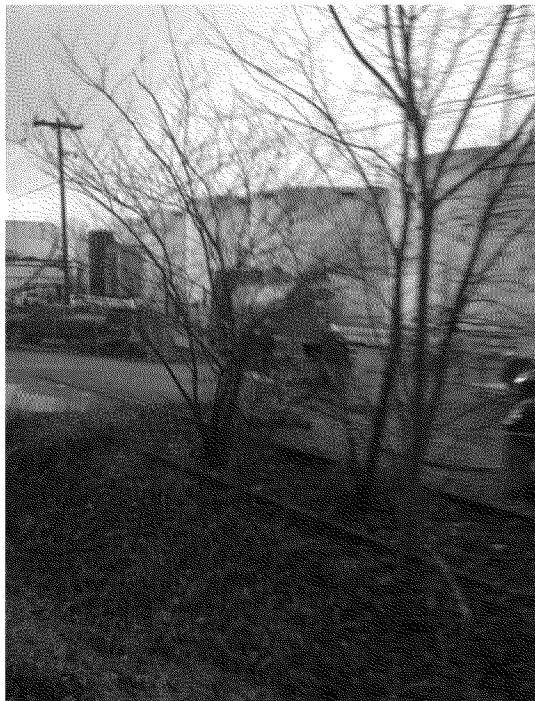
Photo No. IMG_2118; Taken on 01/14/14 at 13:45 hours by START MG. look at site from road

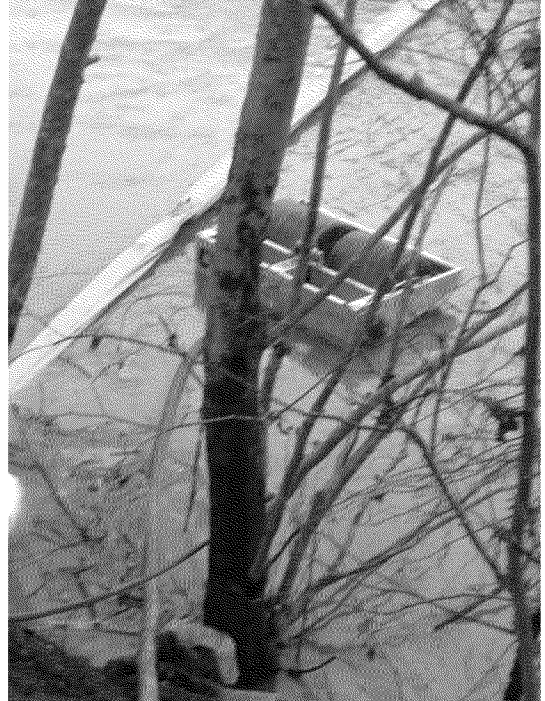
Photo No. IMG_1127; Taken on 01/11/14 at 11:27 hours by START GN. Skimmer used by clean Harbors to skim product collected in river booms.

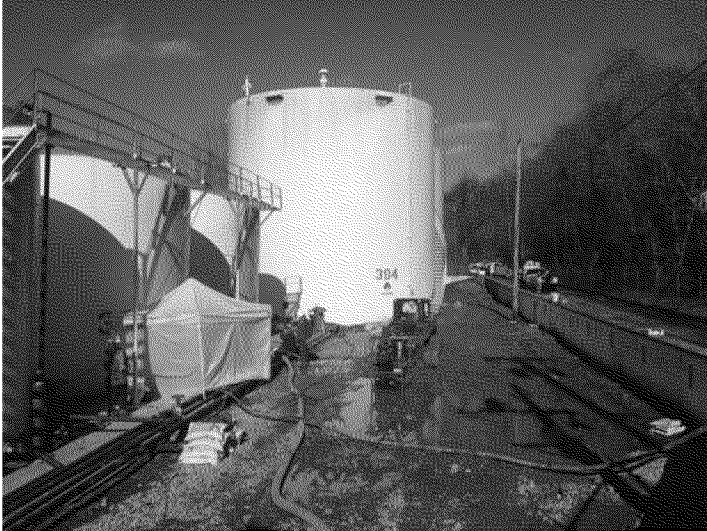
Photo No. IMG_2131; Taken on 01/14/14 at 13:45 hours by START MG. RP Contractors vacuuming product from exploratory pit

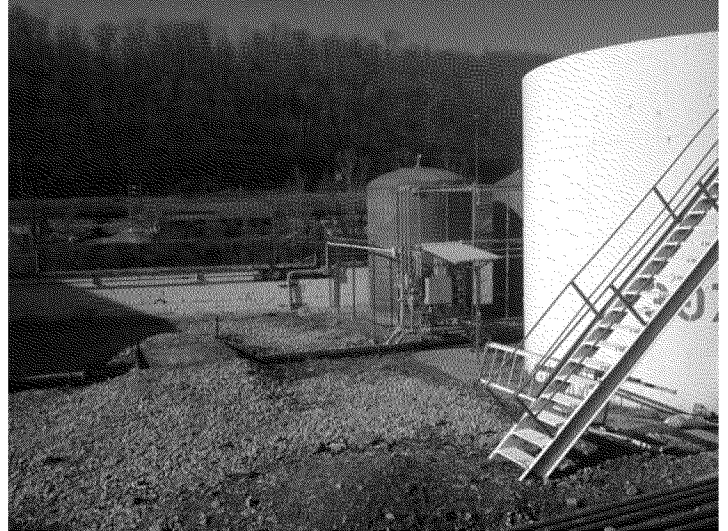
Photo No. IMG_2132; Taken on 01/14/14 at 10:28 hours by START MG. Fatty acids storage tanks behind MCHM tanks

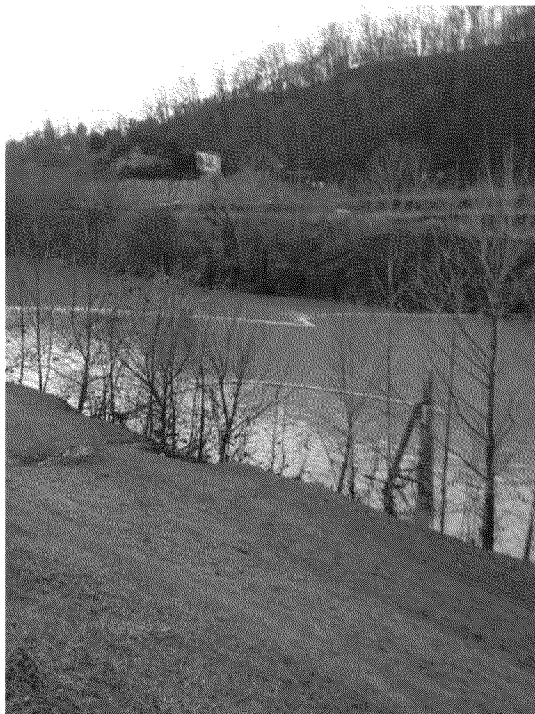
Photo No. to flip_; Taken on 01/13/14 at 14:16 hours by START GN. Boom deployed in the Elk River downstream of the tank farm

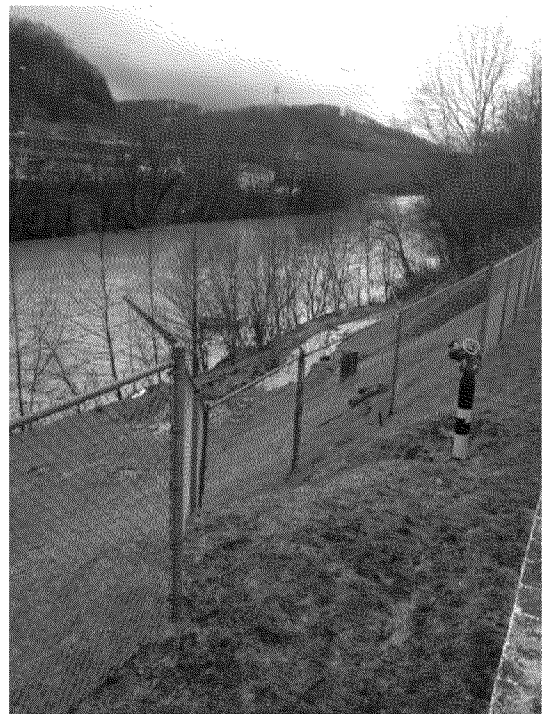
Photo No. to flip_2; Taken on 01/13/14 at 14:16 hours by START GN. Water Containment trench/sump.

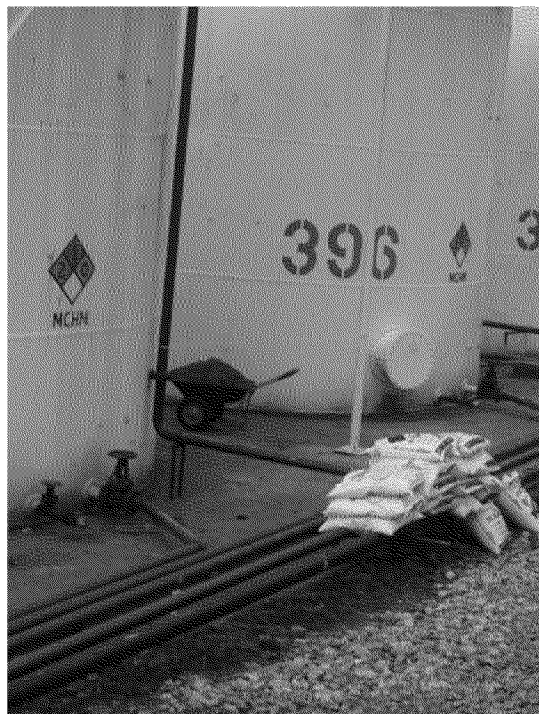
Photo No. to flip_3; Taken on 01/13/14 at 14:16 hours by START GN. Tank 396 from which release occurred.

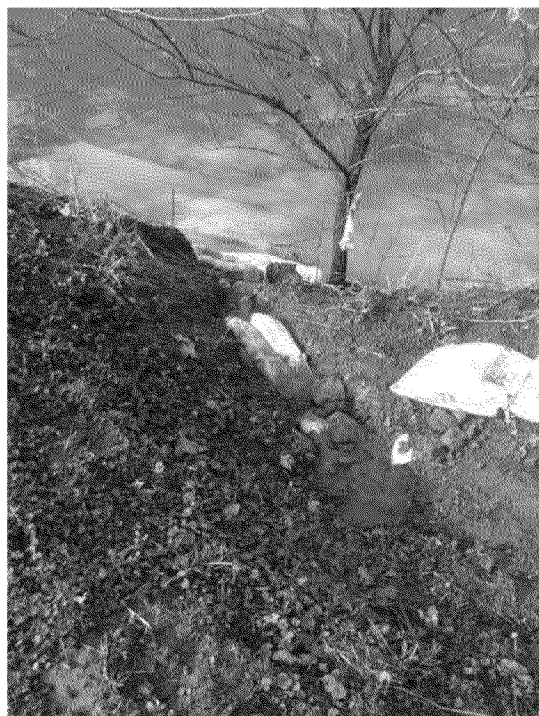
Photo No. to flip_5; Taken on 01/13/14 at 14:17 hours by START GN. Drainage path to river from storm water culvert.

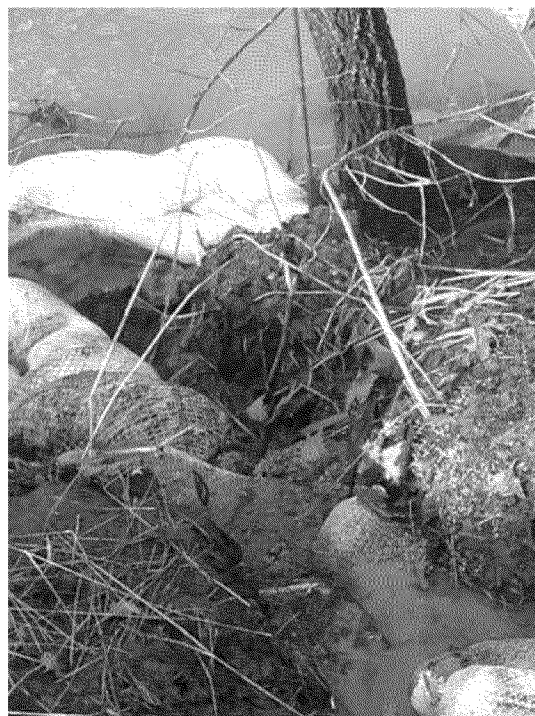
Photo No. to flip_6; Taken on 01/13/14 at 14:17 hours by START GN. Drainage path to river from storm water culvert.

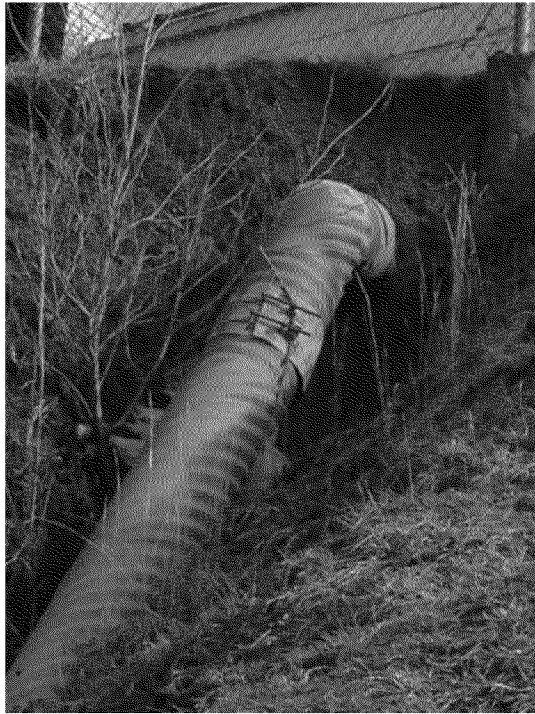
Photo No. to flip_7; Taken on 01/13/14 at 14:31 hours by START GN. Water leaking from storm water pipe below tank farm.

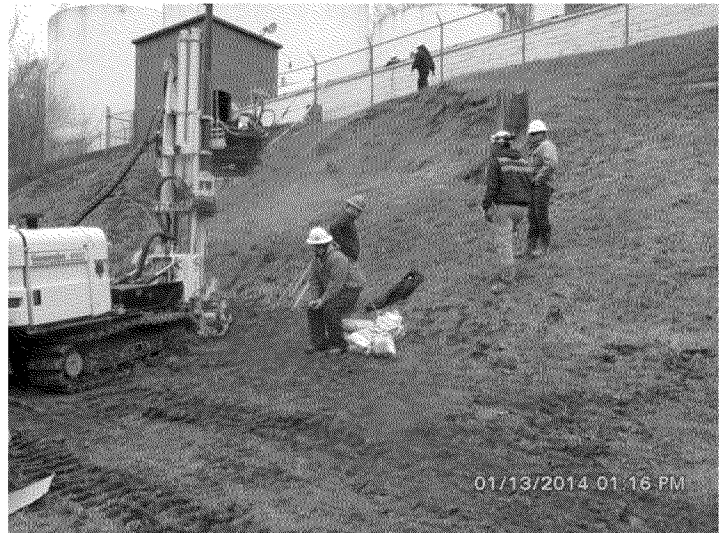
Photo No. SAM_1598; Taken on 01/13/14 at 13:20 hours by START MD. Geoprobe taking core sample at foot of slope below breached tank

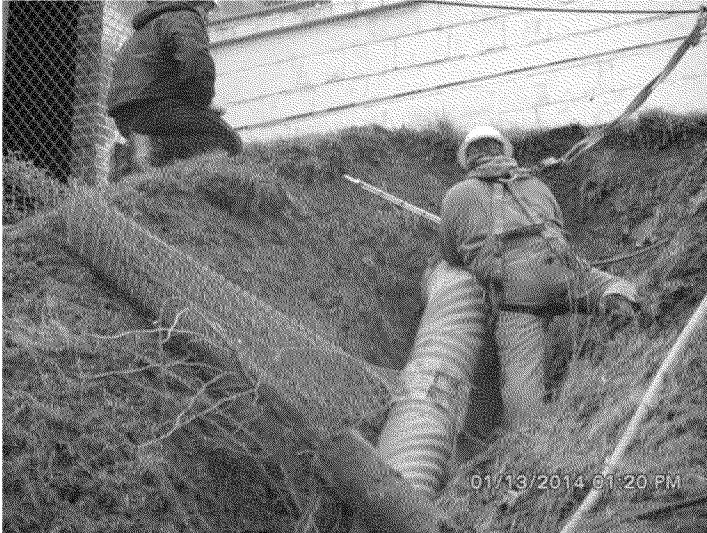
Photo No. SAM_1599; Taken on 01/13/14 at 13:20 hours by
START MD. Cutting of faulty storm drain

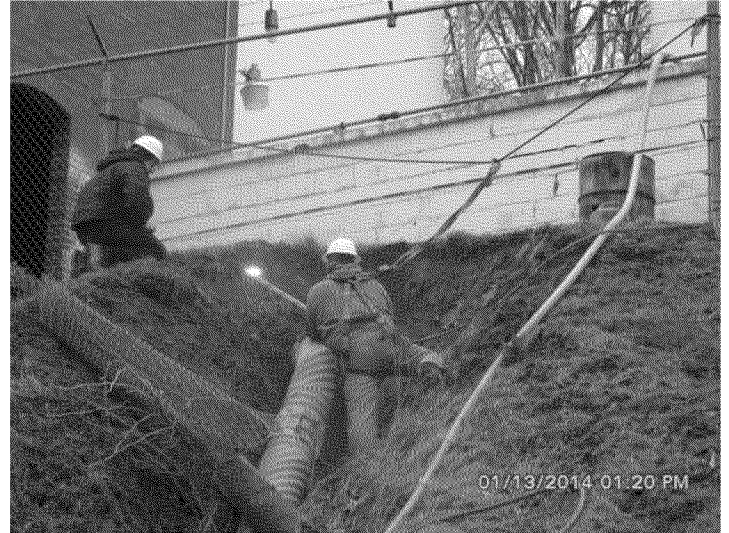
Photo No. SAM_1600; Taken on 01/13/14 at 13:20 hours by
START MD. Cutting of faulty storm drain

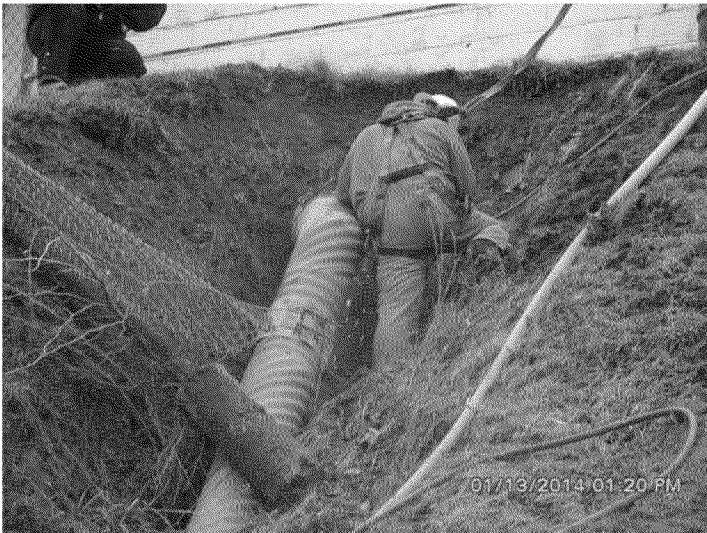
Photo No. SAM_1601; Taken on 01/13/14 at 13:20 hours by
START MD. Cutting of faulty storm drain

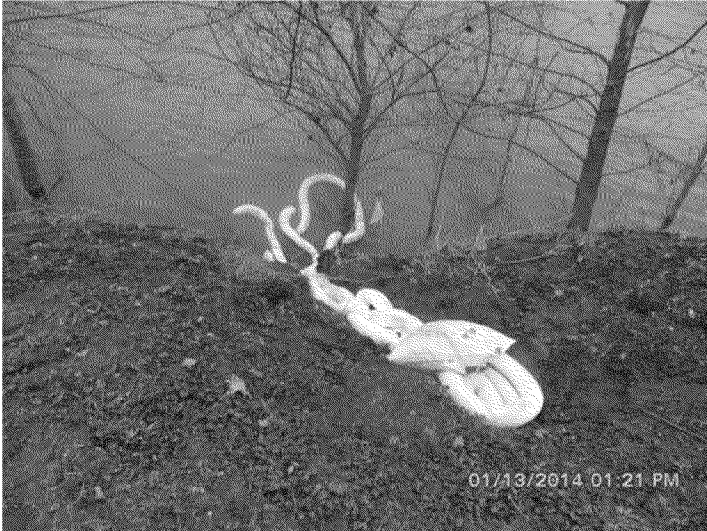
Photo No. SAM_1603; Taken on 01/13/14 at 13:22 hours by START MD . Absorbent boom placed in discharge of the storm drain

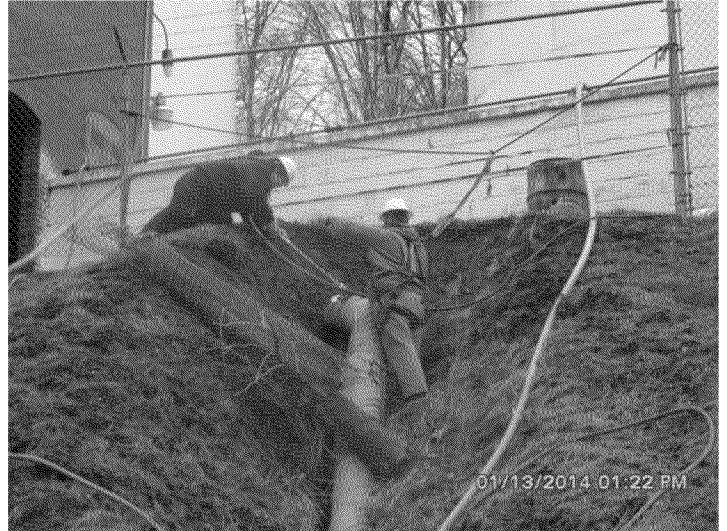
Photo No. SAM_1604; Taken on 01/13/14 at 13:22 hours by START MD . Cutting of faulty storm drain

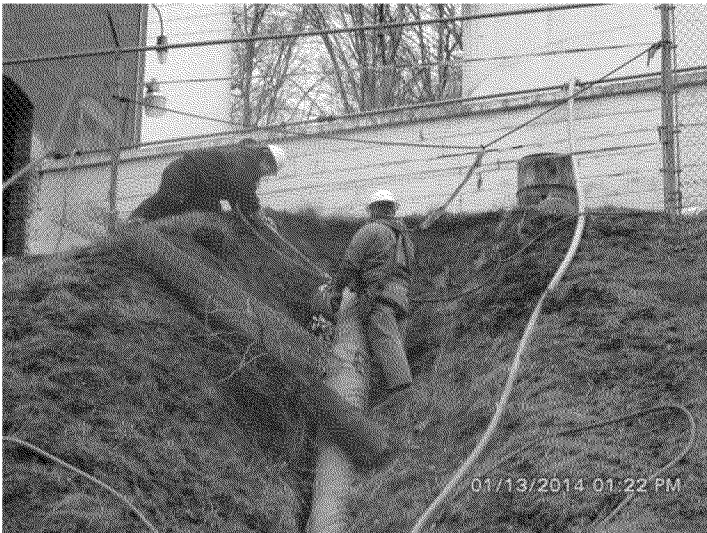
Photo No. SAM_1605; Taken on 01/13/14 at 13:24 hours by START MD. Cutting of faulty storm drain

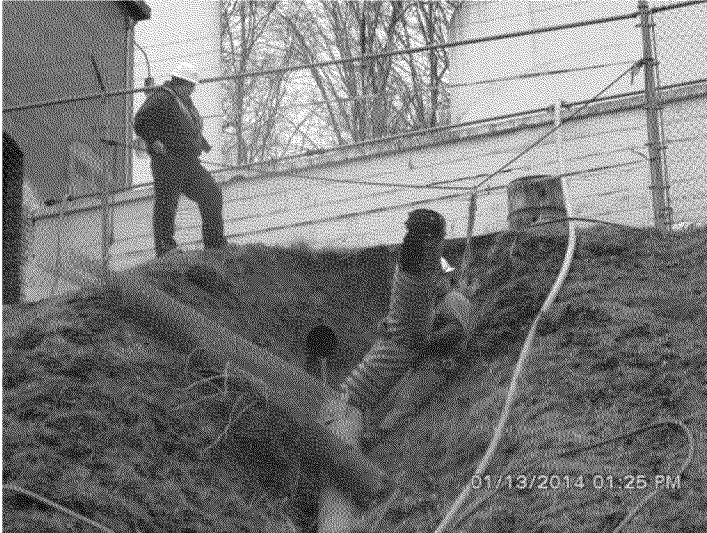
Photo No. SAM_1607; Taken on 01/13/14 at 13:36 hours by START MD. Removal of section of faulty storm drain

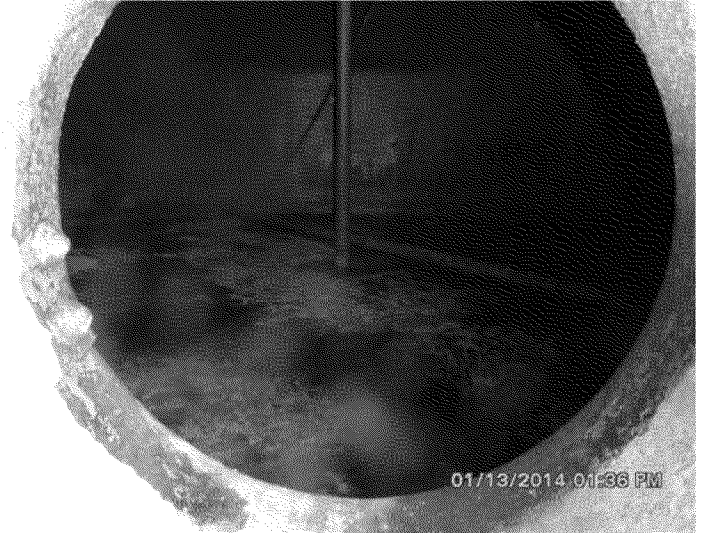
Photo No. SAM_1608; Taken on 01/13/14 at 13:36 hours by START MD. Inside of breached tank

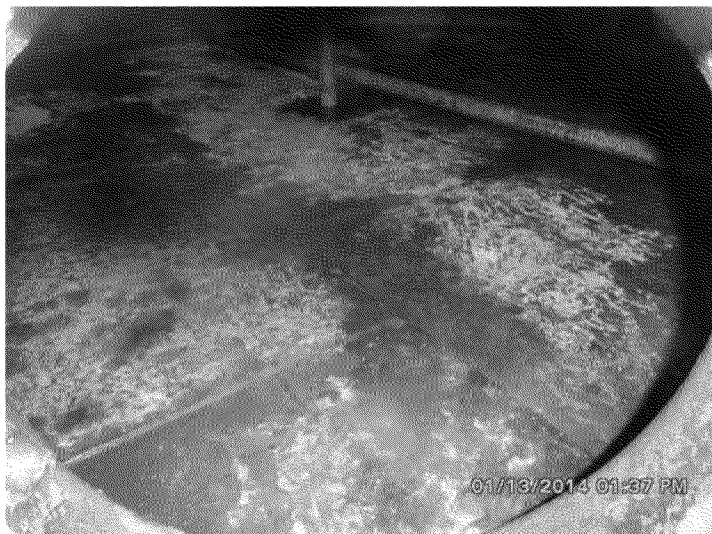
Photo No. SAM_1612; Taken on 01/13/14 at 13:37 hours by START MD. Inside of breached tank

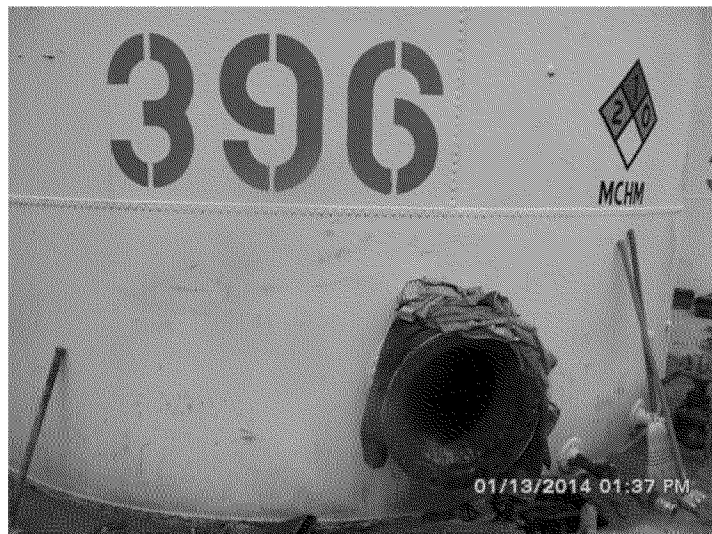
Photo No. SAM_1613; Taken on 01/13/14 at 13:38 hours by START MD. Look at man entrance into breached tank

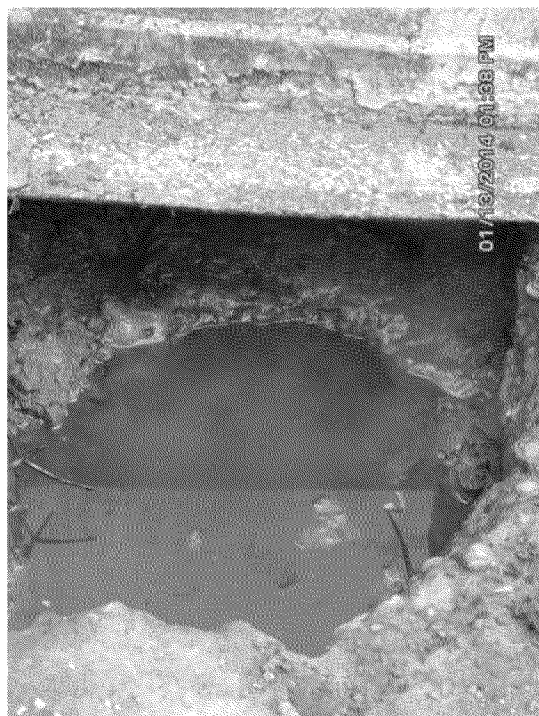
Photo No. SAM_1614; Taken on 01/13/14 at 13:38 hours by START MD. Product surfacing in exploratory pit under edge of the breached tank

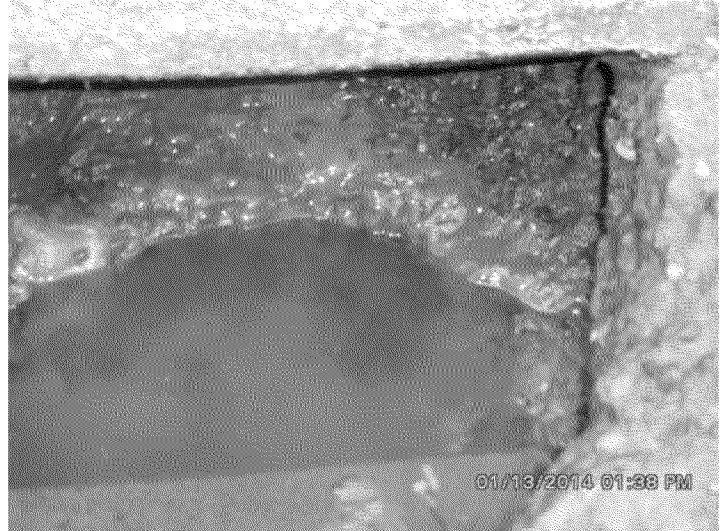
Photo No. SAM_1617; Taken on 01/13/14 at 13:39 hours by START MD. Product seeping out from under breached tank

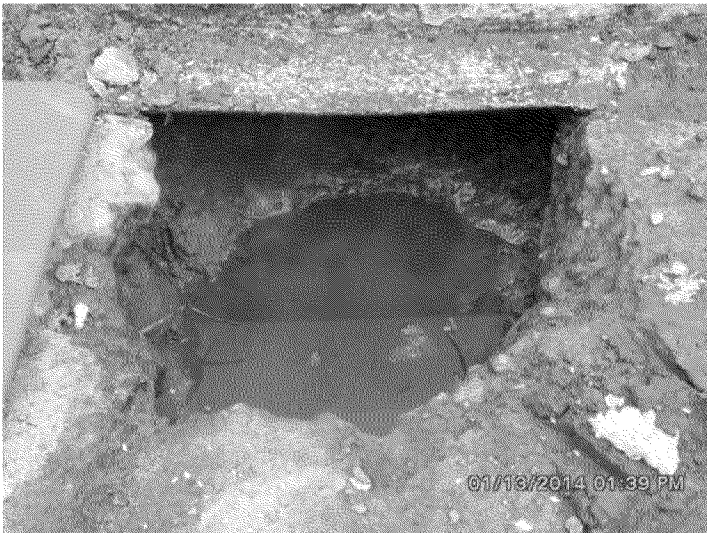
Photo No. SAM_1618; Taken on 01/13/14 at 13:39 hours by START MD. Product in exploratory pit under edge of breached tank

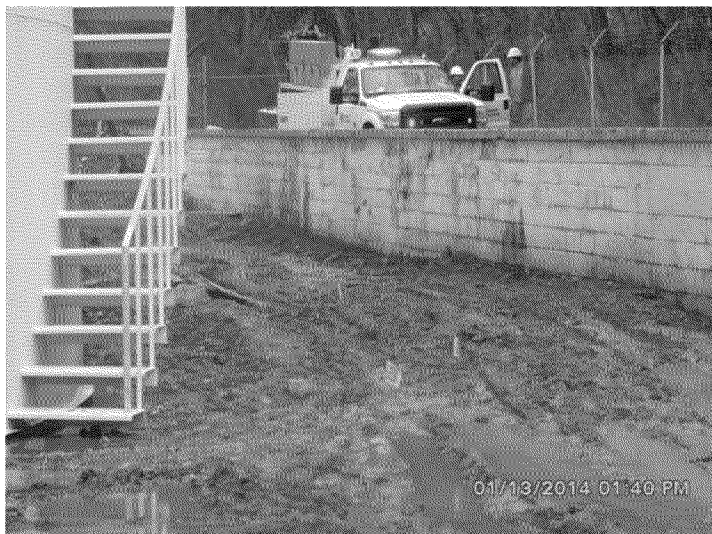
Photo No. SAM_1620; Taken on 01/13/14 at 13:41 hours by
START MD. underground gas line marked in containment area

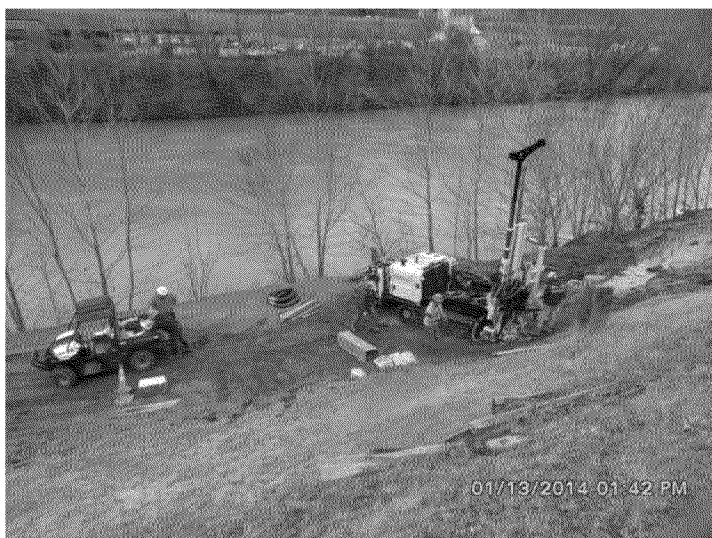
Photo No. SAM_1622; Taken on 01/13/14 at 13:43 hours by
START MG. Geoprobe crew installing monitoring well

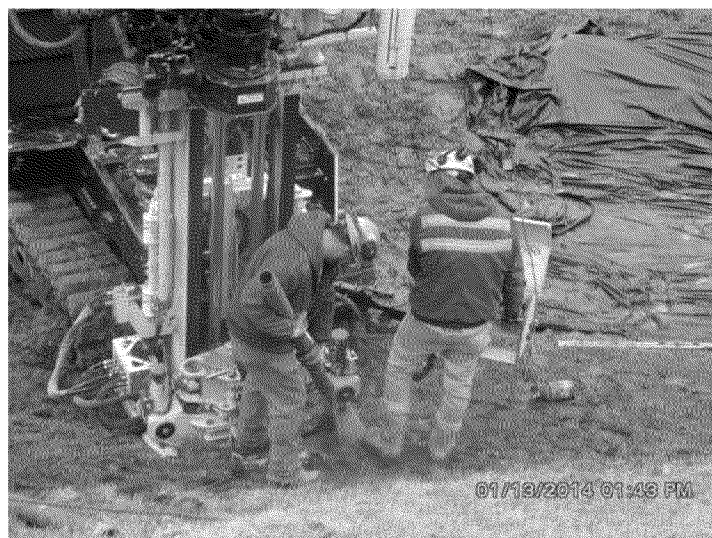
Photo No. SAM_1623; Taken on 01/13/14 at 13:48 hours by
START MG. Installation of monitoring well below breached
tank

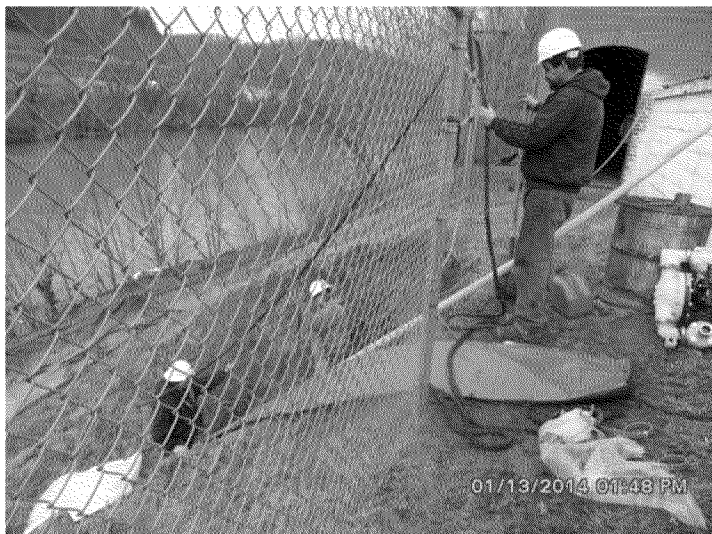
Photo No. SAM_1624; Taken on 01/13/14 at 14:37 hours by START MG. Workers building sump area under storm drain pipe

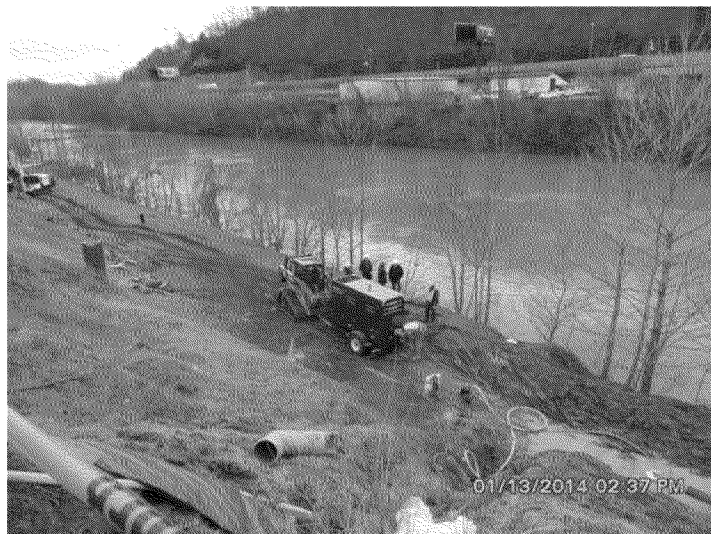
Photo No. SAM_1625; Taken on 01/13/14 at 14:37 hours by START MG. Pump being put in place in containment pond

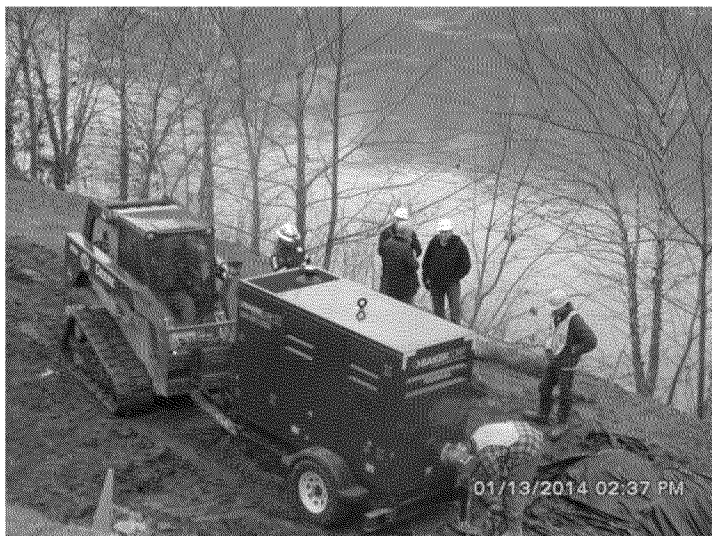
Photo No. SAM_1626; Taken on 01/13/14 at 14:47 hours by START MG. Pump used for evacuation of containment pond

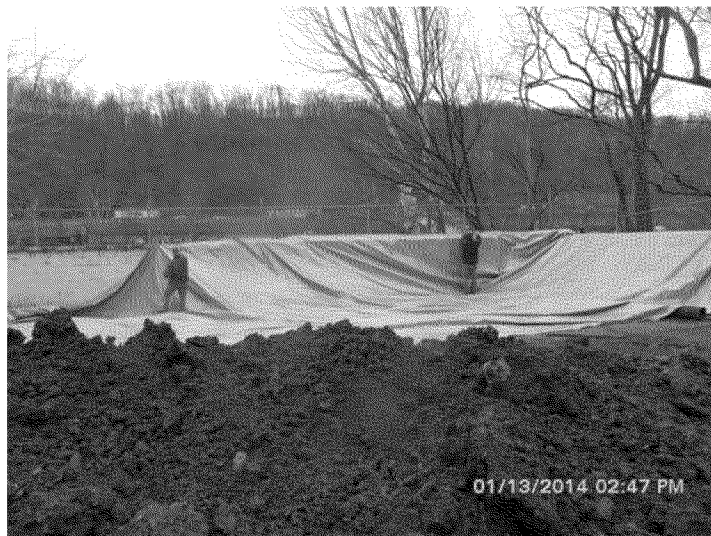
Photo No. SAM_1627; Taken on 01/13/14 at 14:56 hours by START MG. Tarps being placed in area of breached containment wall

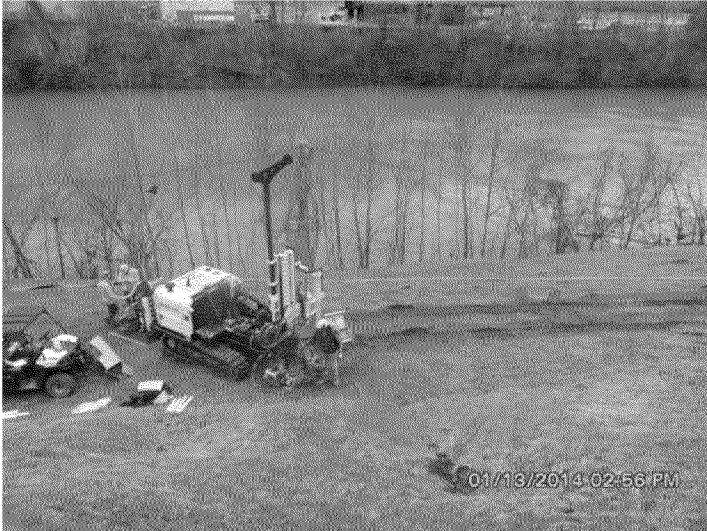
Photo No. SAM_1628; Taken on 01/13/14 at 15:28 hours by START MG. Geoprobe setting up to collect core sample of a second location below tanks

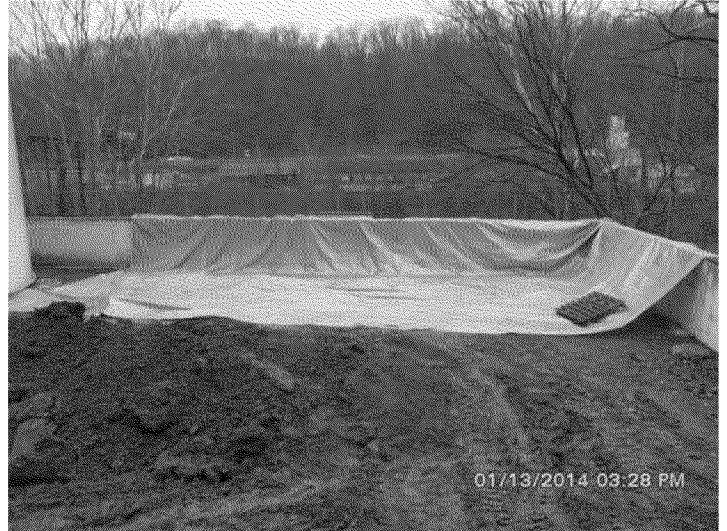
Photo No. SAM_1629; Taken on 01/13/14 at 17:03 hours by START MG. Tarp in place to divert storm water away from breached containment wall

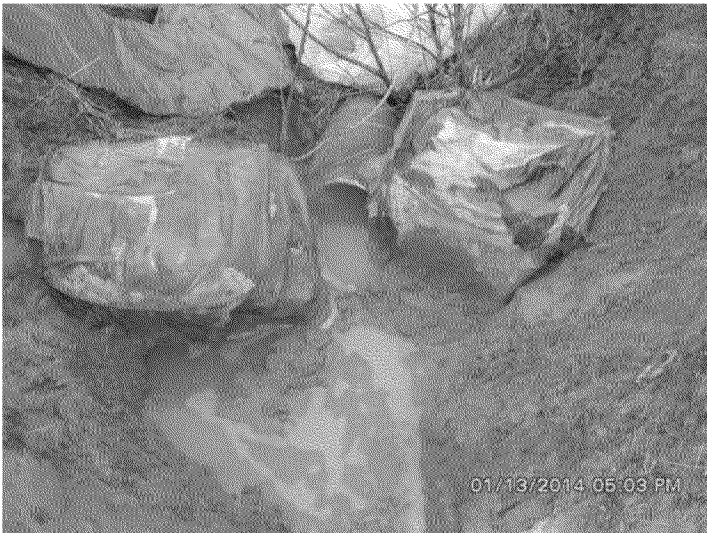
Photo No. SAM_1630; Taken on 01/13/14 at 17:03 hours by START MG . Start for diking off the storm drain

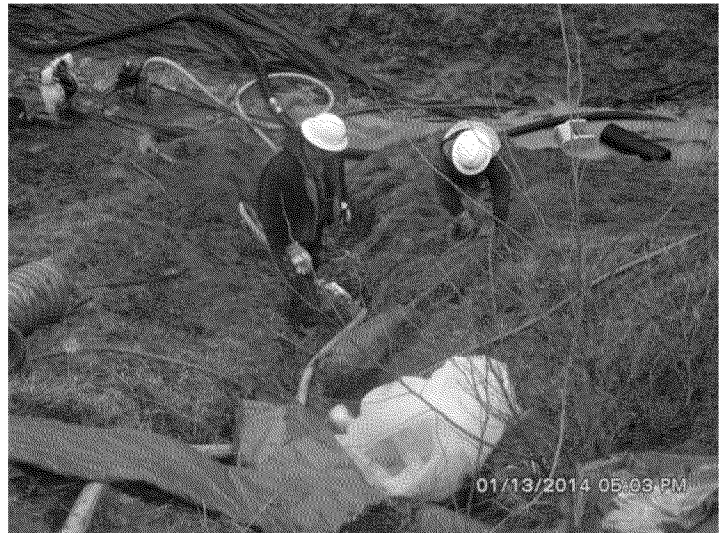
Photo No. SAM_1631; Taken on 01/13/14 at 18:14 hours by START MG . Debris being removed from hillside area before liner installation

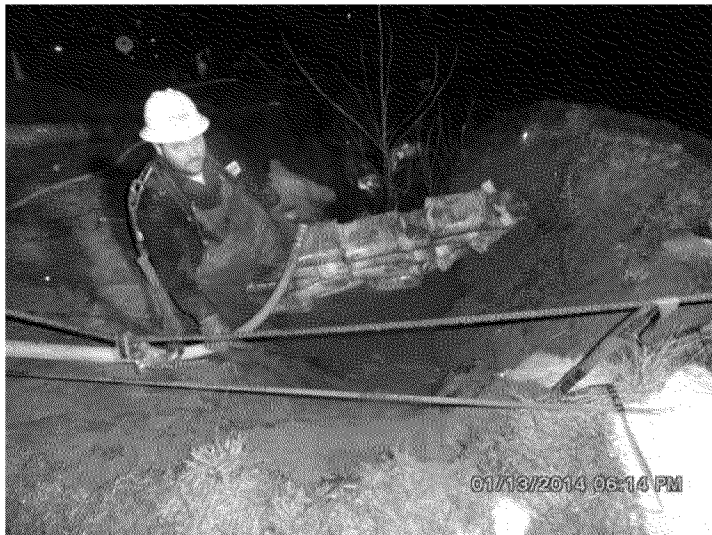
Photo No. SAM_1632; Taken on 01/13/14 at 18:14 hours by START MG. Containment dike in place and storm water being pumped from behind

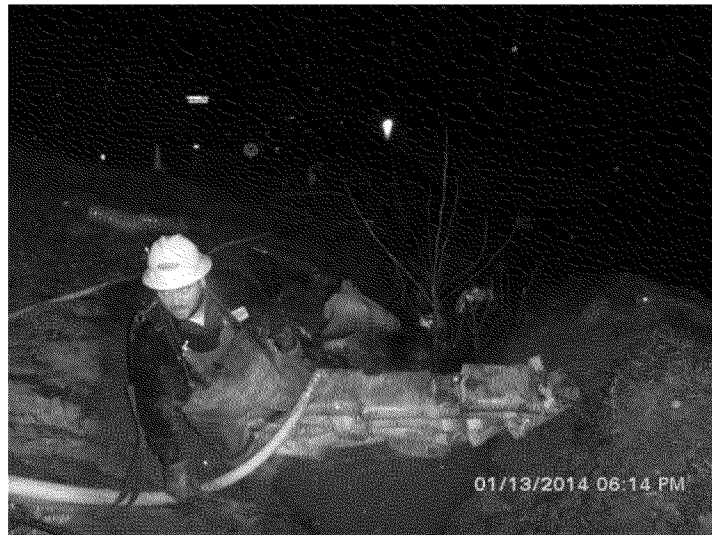
Photo No. SAM_1633; Taken on 01/13/14 at 14:16 hours by START MG. Containment dike in place and storm water being pumped from behind

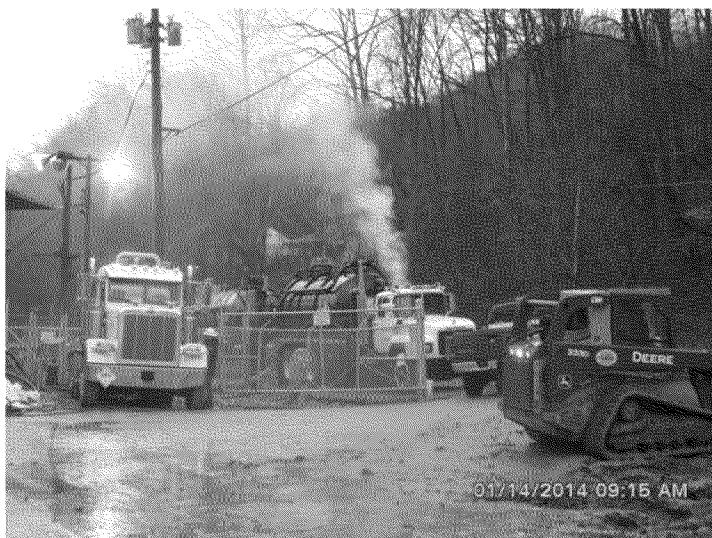
Photo No. SAM_1634; Taken on 01/14/14 at 9:16 hours by START MG. Steam Discharge from vac truck

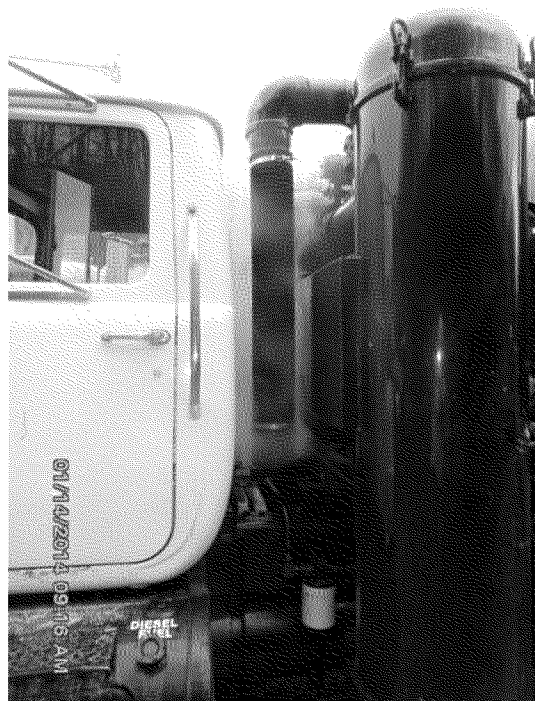
Photo No. SAM_1635; Taken on 01/14/14 at 9:40 hours by START MG. Steam Discharge from vac truck

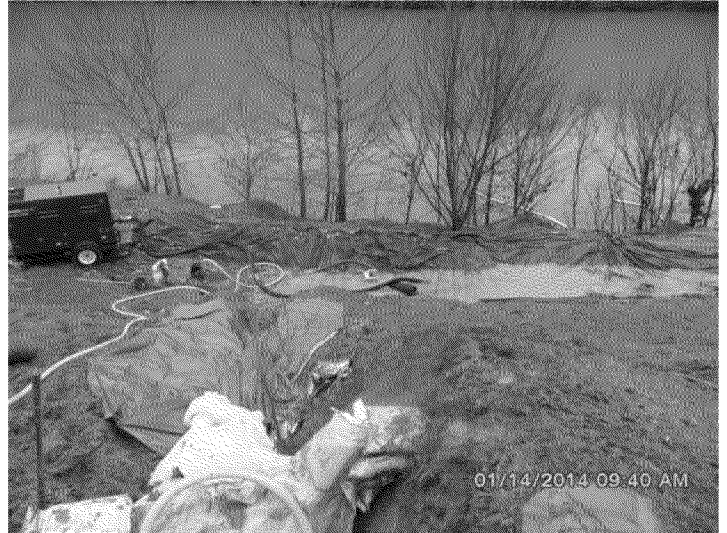
Photo No. SAM_1637; Taken on 01/14/14 at 9:46 hours by
START MG. containment pond being pumped out

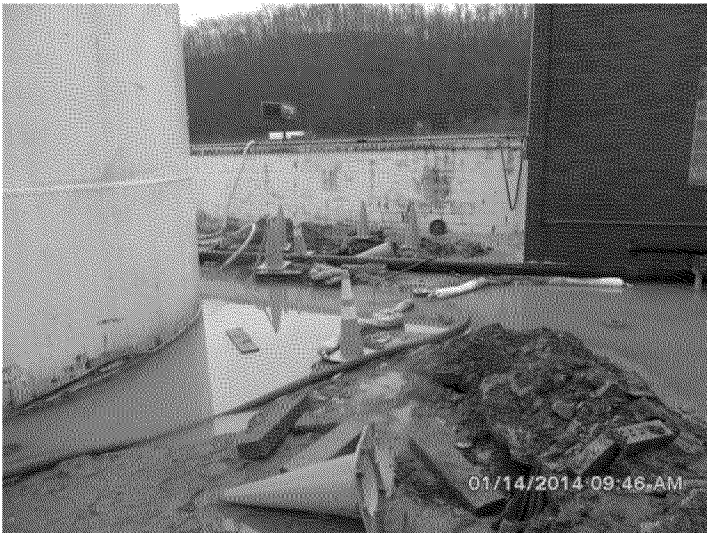
Photo No. SAM_1638; Taken on 01/14/14 at 9:46 hours by
START MG. storm water laying inside containment area

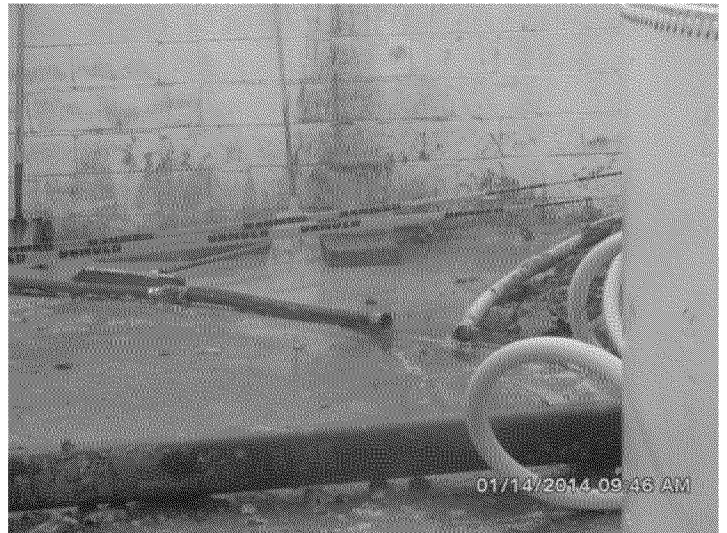
Photo No. SAM_1639; Taken on 01/14/14 at 9:47 hours by
START MG. Storm drain discharge water being pumped back
into containment area

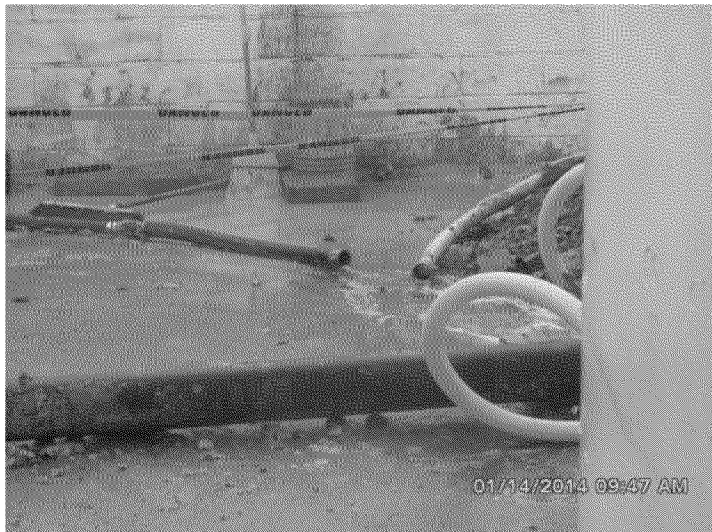
Photo No. SAM_1640; Taken on 01/14/14 at 9:48 hours by START MG. Storm drain discharge water being pumped back into containment area

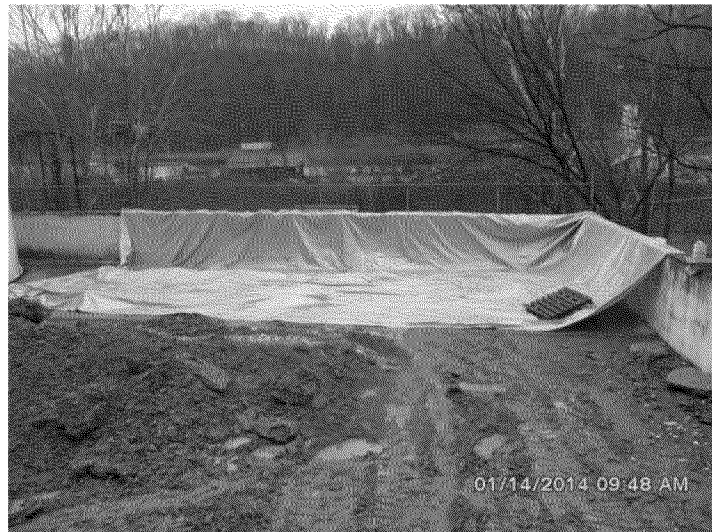
Photo No. SAM_1641; Taken on 01/14/14 at 9:49 hours by START MG. Tarps in place to divert storm runoff from breached containment wall

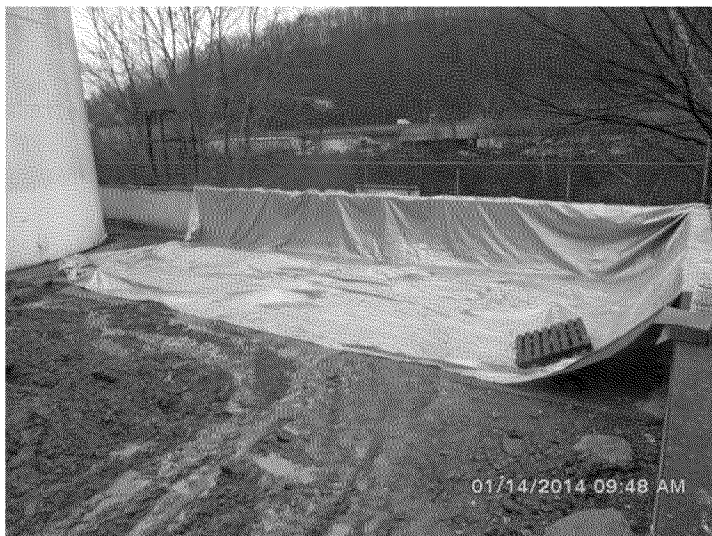
Photo No. SAM_1642; Taken on 01/14/14 at 10:01 hours by START MG. Tarps in place to divert storm runoff from breached containment wall

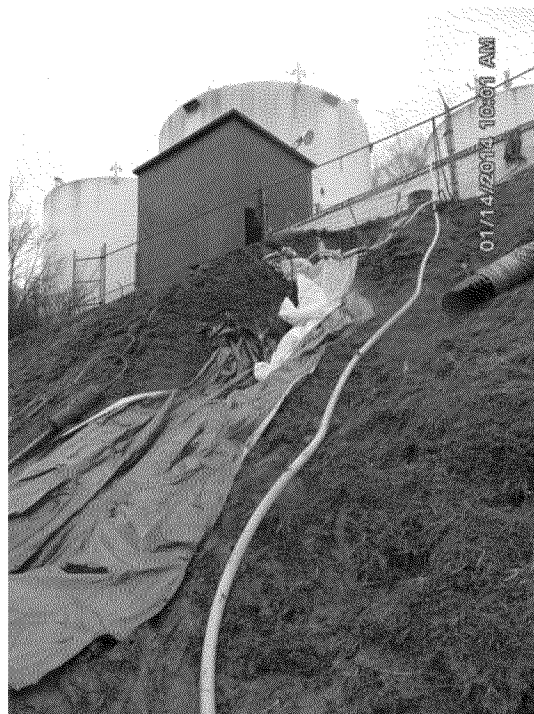
Photo No. SAM_1643; Taken on 01/14/14 at 10:30 hours by START MG. Plastic and tarps being used to funnel water down the hill into the collection trench/pond

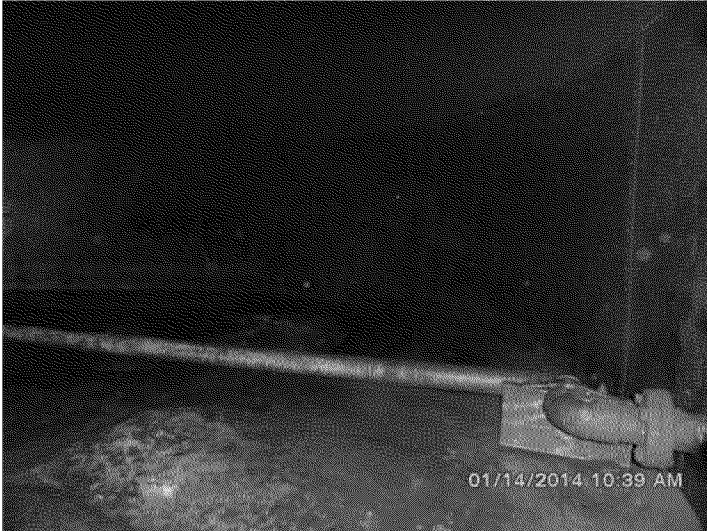
Photo No. SAM_1645; Taken on 01/14/14 at 10:41 hours by START MG. Photo inside the tank

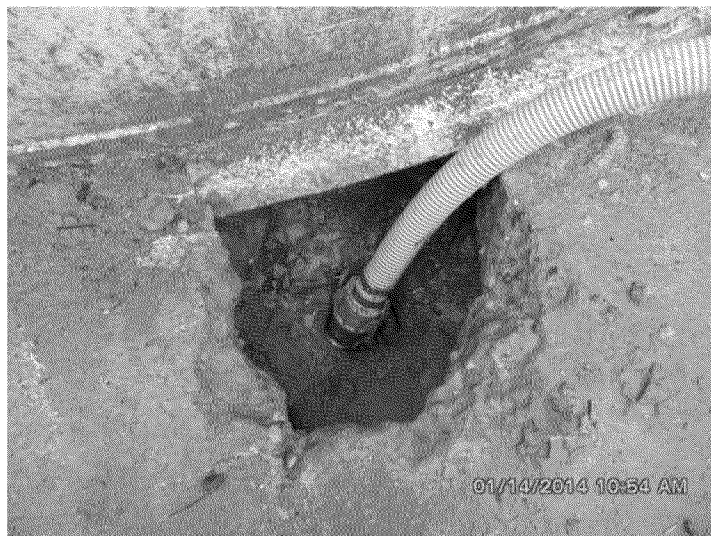
Photo No. SAM_1656; Taken on 01/14/14 at 10:54 hours by START MG. Vacuum hose in exploratory pit under the edge of the breached tank

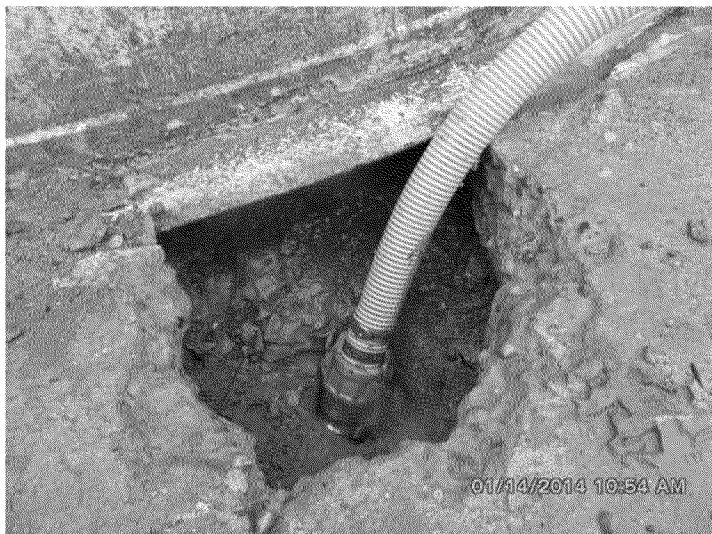
Photo No. SAM_1657; Taken on 01/14/14 at 10:54 hours by START MG. Vacuum hose in exploratory pit under the edge of the breached tank
